C4 Brake Switch causing ESP/ABS fault or Speed limit error message, Switch replacement guide.

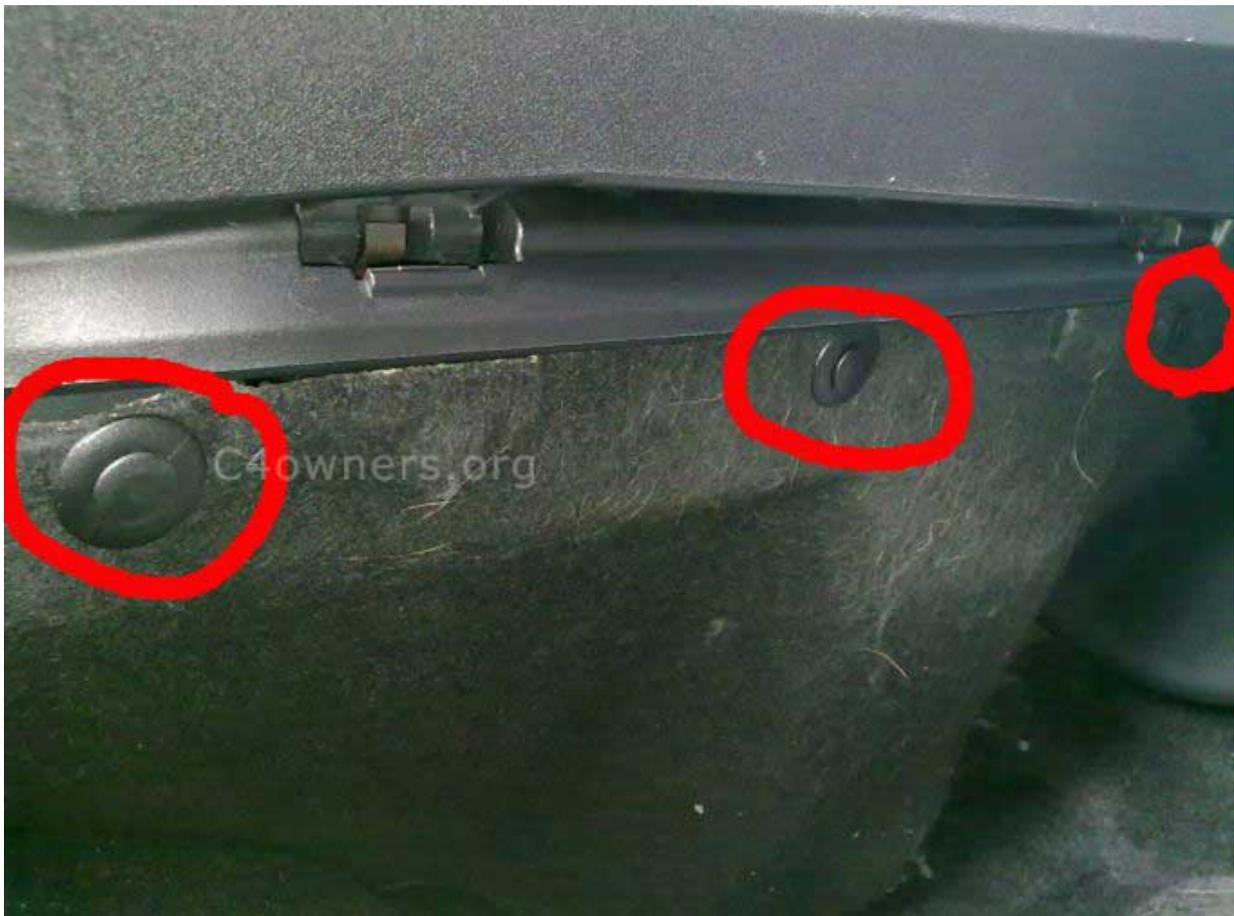
In the passenger foot well, there are three plastic rivets which need to be removed and placed safely together.

They are easily removed by gripping the inner part and pulling out.

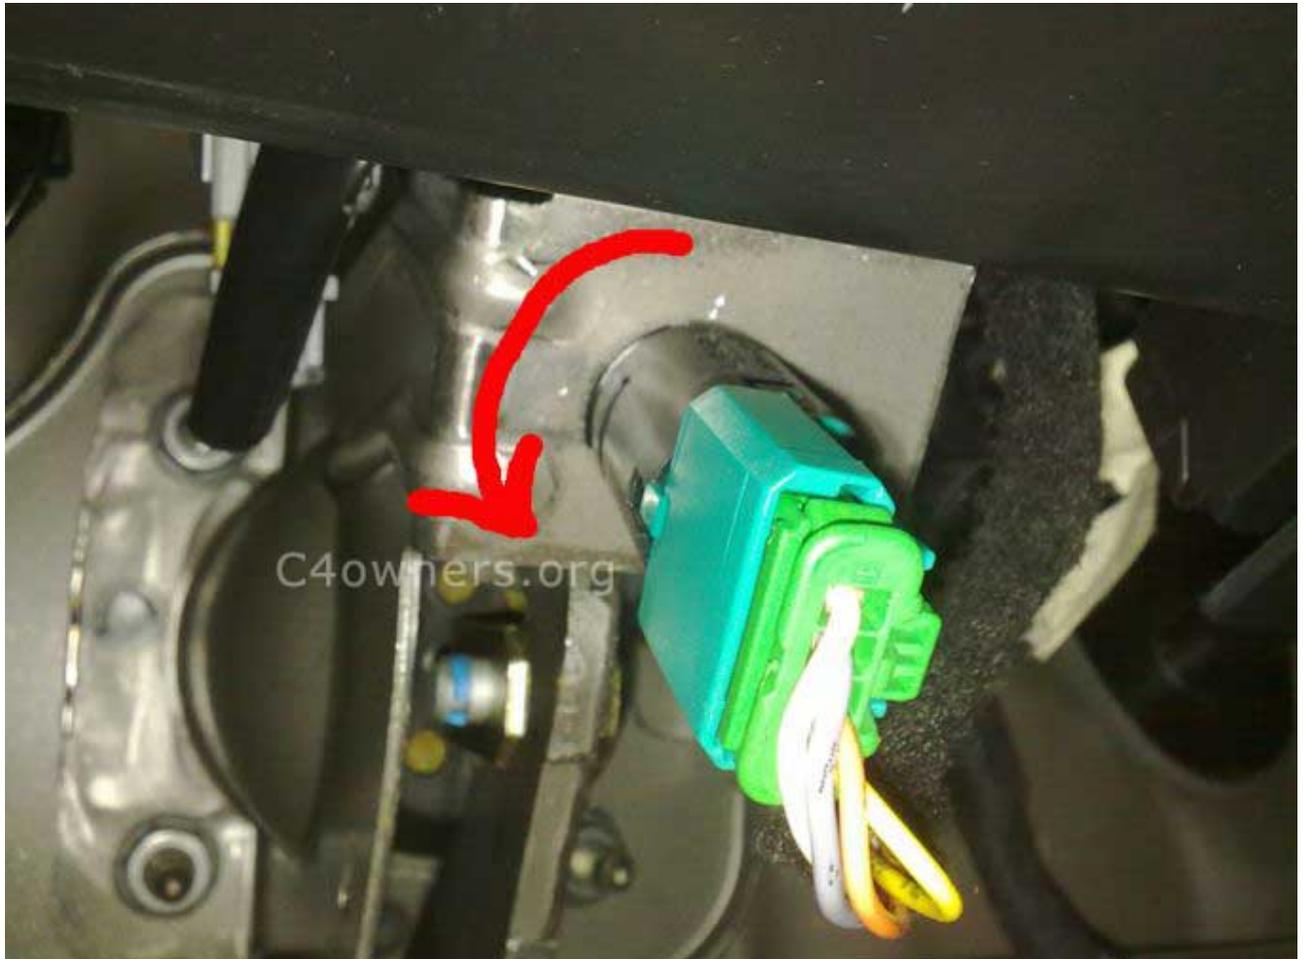
Here's the Switch which comes as a kit with a new loom which I was told has a resistor in it.

To remove the switch, grip and rotate the switch 90 degrees anti clockwise, then disconnect the connector.

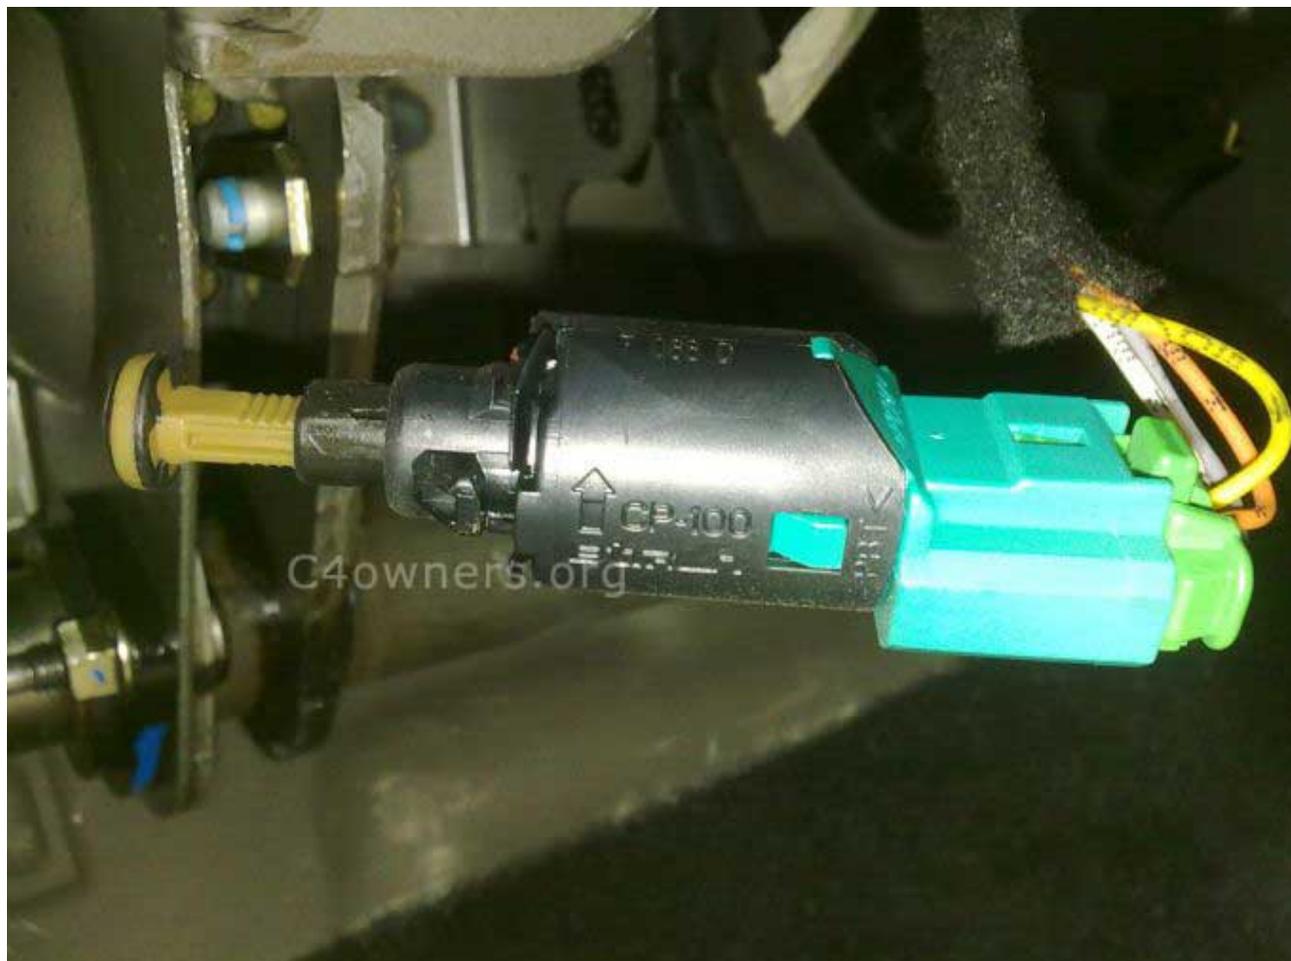
When replacing the old switch for the new one, you need to set the plunger new switch to the same length as the old one. This is done by pushing or pulling taking care not to damage it.

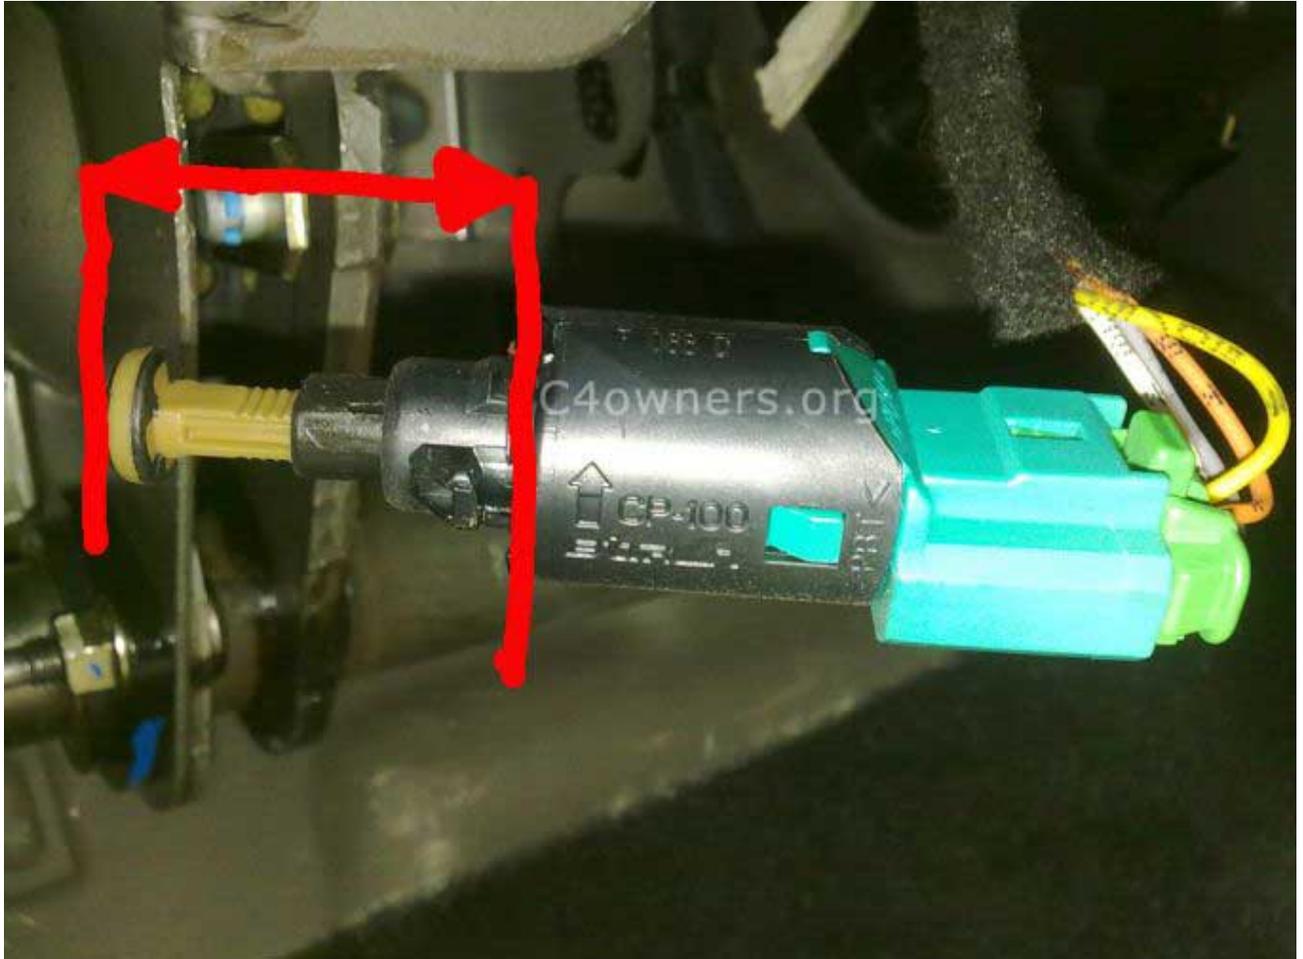
This photo shows where to measure/compare the "plunger"

Replace the switch by pushing it into the hole and rotating clockwise 90 degrees. turn on ignition and check that the brake lights work, if not the switch plunger might not be set to the correct length.
