Frequently Asked Questions

Change the C4 1.6HDi Turbo / Exhaust Heat Shield

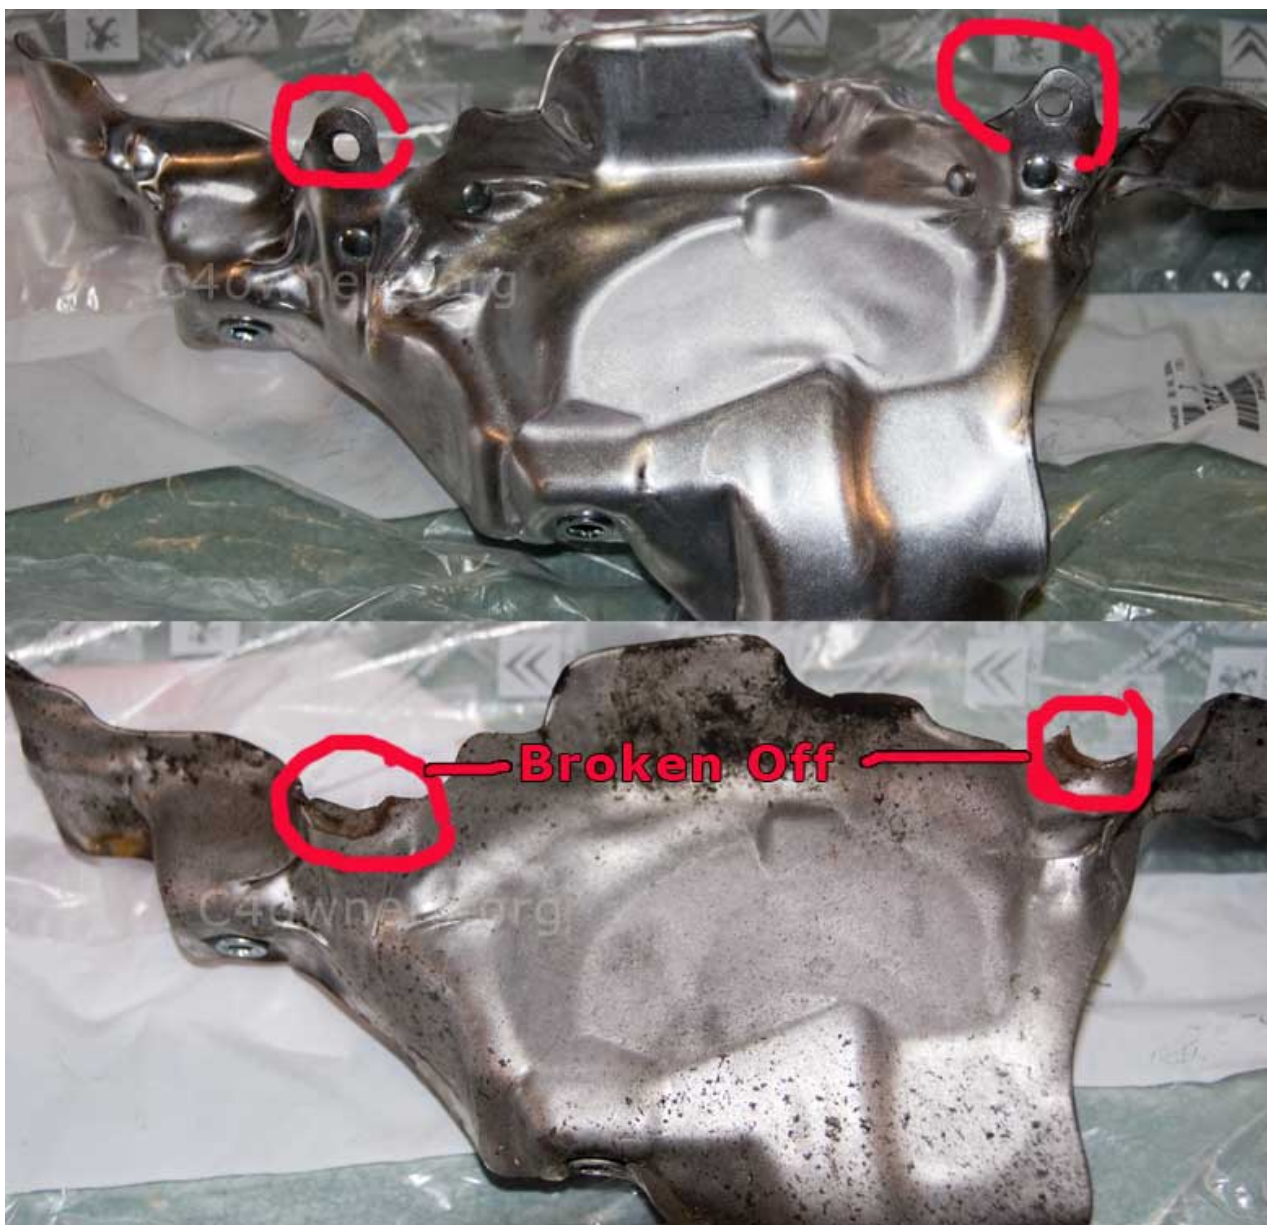
The front securing lugs on the heat shield are a known weak point on this engine and can fail through 'fatigue'.

The lugs failing don't cause any real issues as the shield can't go anywhere but it can let hot air rise to the turbo and cause an annoying rattle (and diesels can be noisy enough..!)

Citroën have updated the securing points for later models.

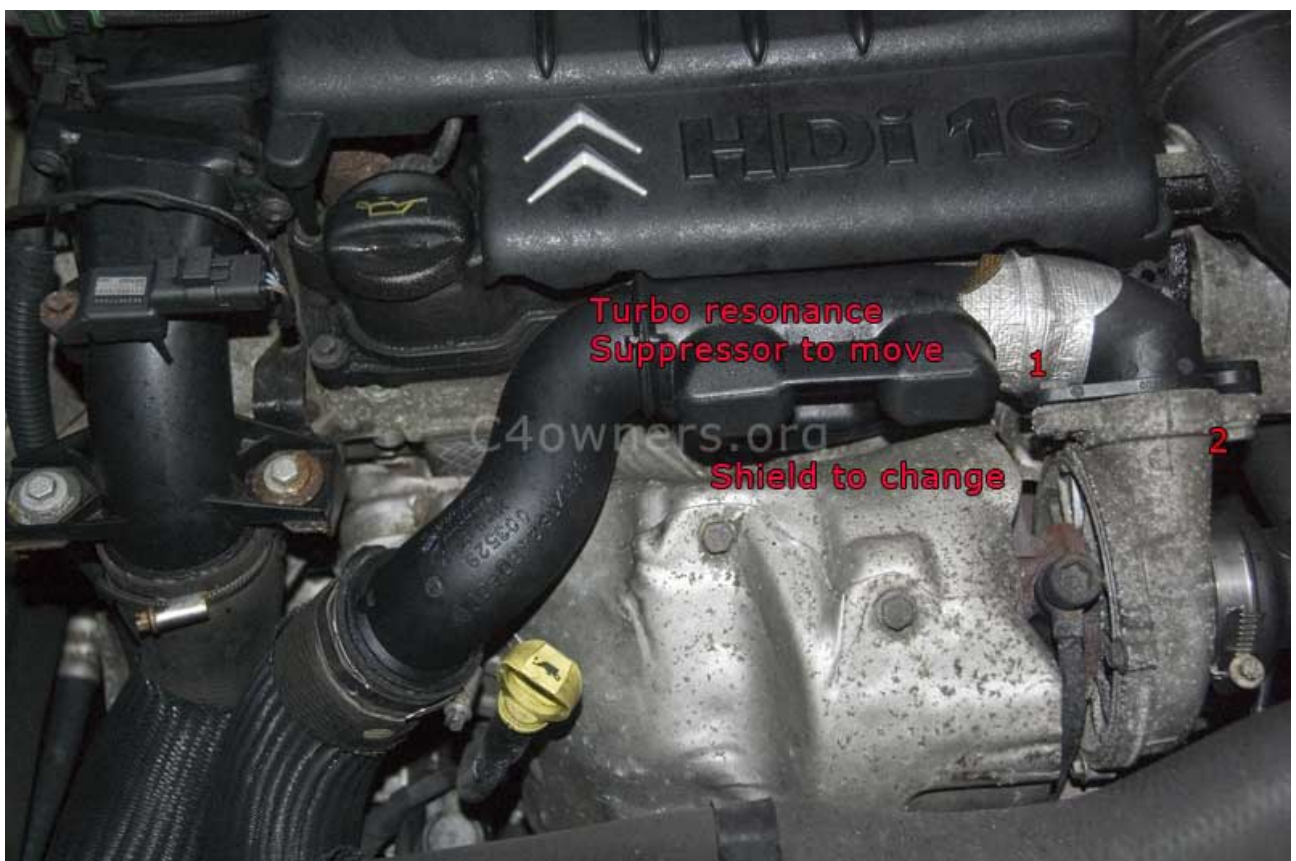
Step one is to remove the Engine Cover and Turbo Resonance Suppressor to gain access to the engine side securing bolts. For this you only need a 10mm combination spanner (open jaw and ring) as there is no room for a socket.

First simply lift the engine cover up and pull out (you will) need to lift the rear scuttle panel under the wiper arms at the front a bit so it slides out.)

Next you need to remove the bolt marked '2' in the picture and slacken bolt marked '1' - the resonator pipe will then come out by lifting at the left hand side to free the push fit locating lug then twisting slightly up and toward you so it clears bolt '1' then pull back toward the bulkhead.

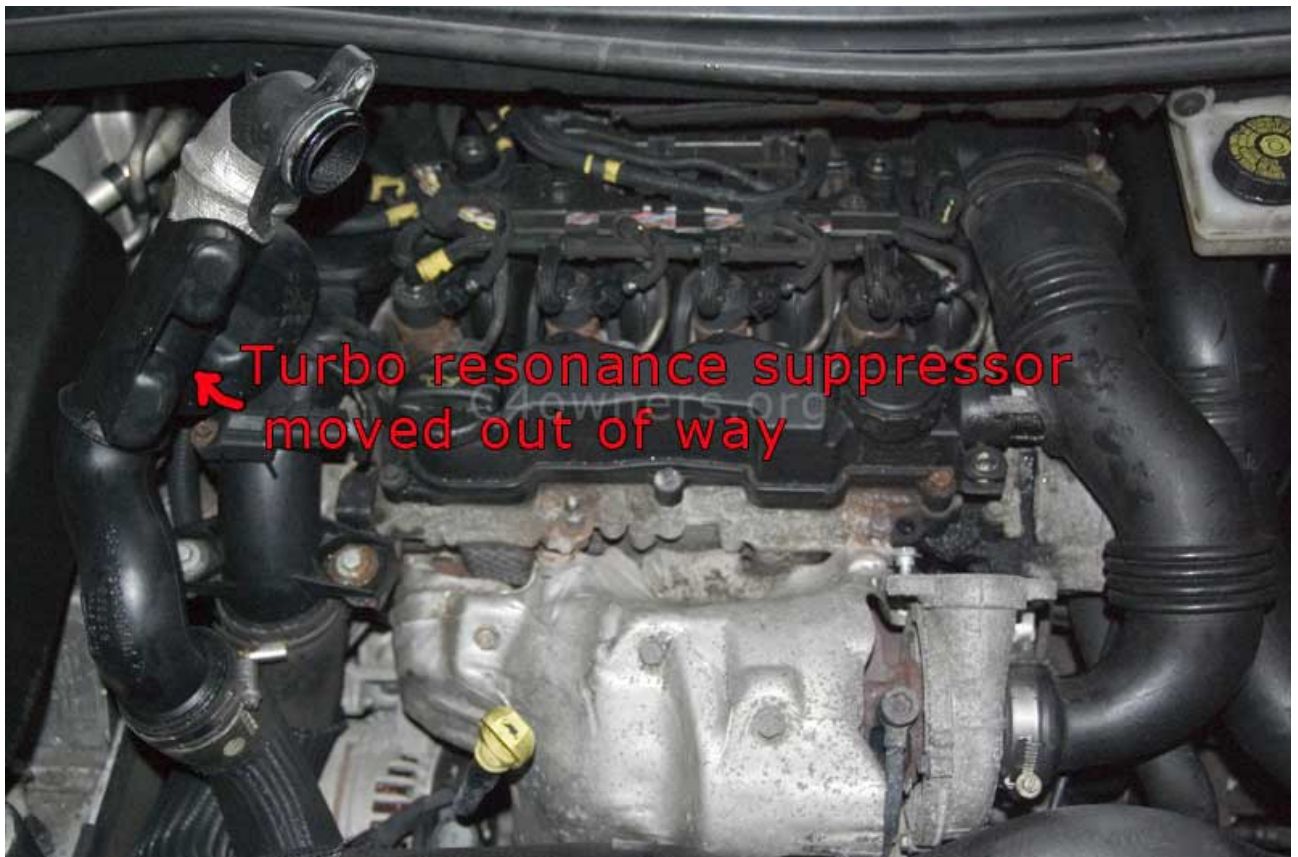
Once clear simply move over to the left side of the engine bay so you can see the part of the shield that you need to to change

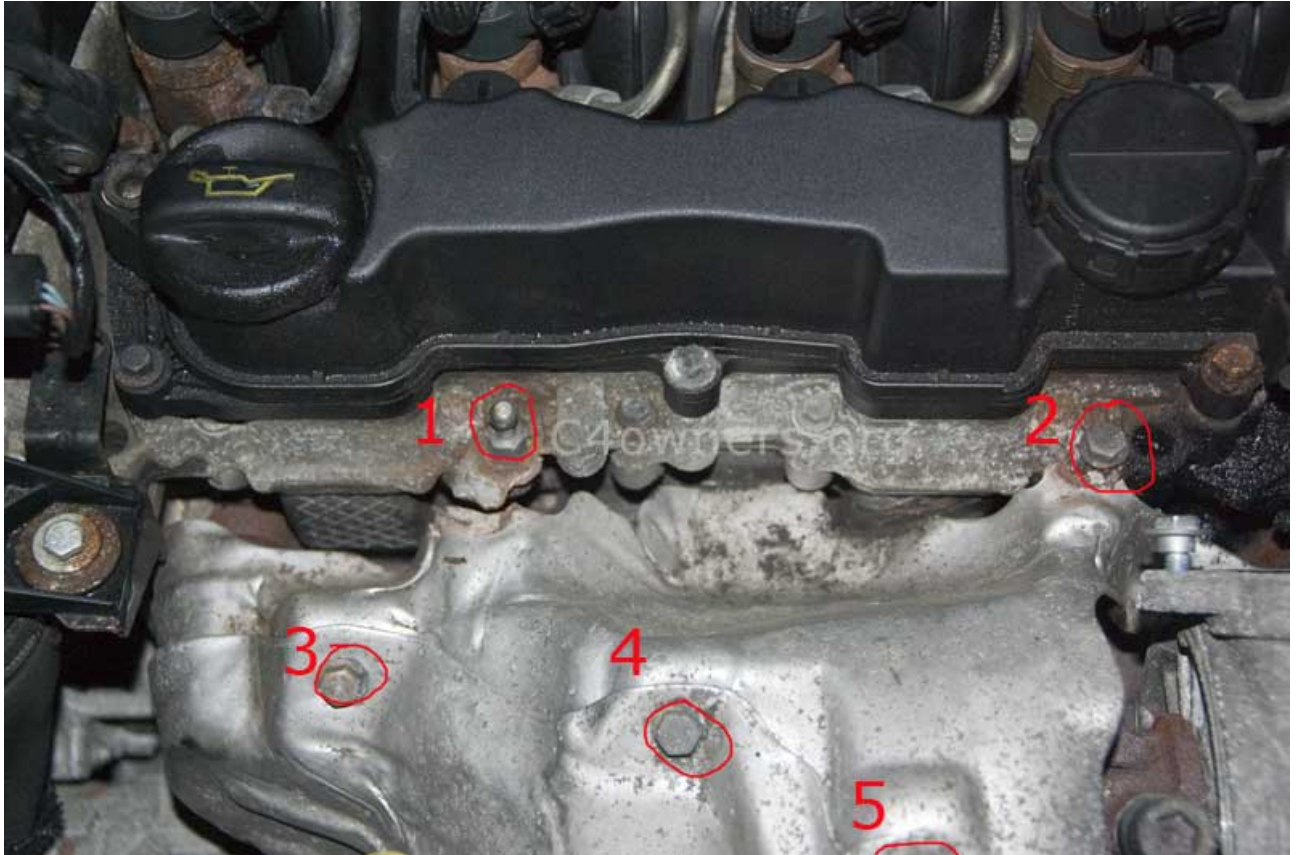
Now you need to remove the 5 bolts indicated to free the broken part of the heat shield.

Start with the 2 engine side ones and when out lay to one side.

Then remove the 3 heat shield joining ones just making sure the shield doesn't drop.

Next you have to manoeuvre the old broken shield out which will require a bit of tugging backward on the outer part.

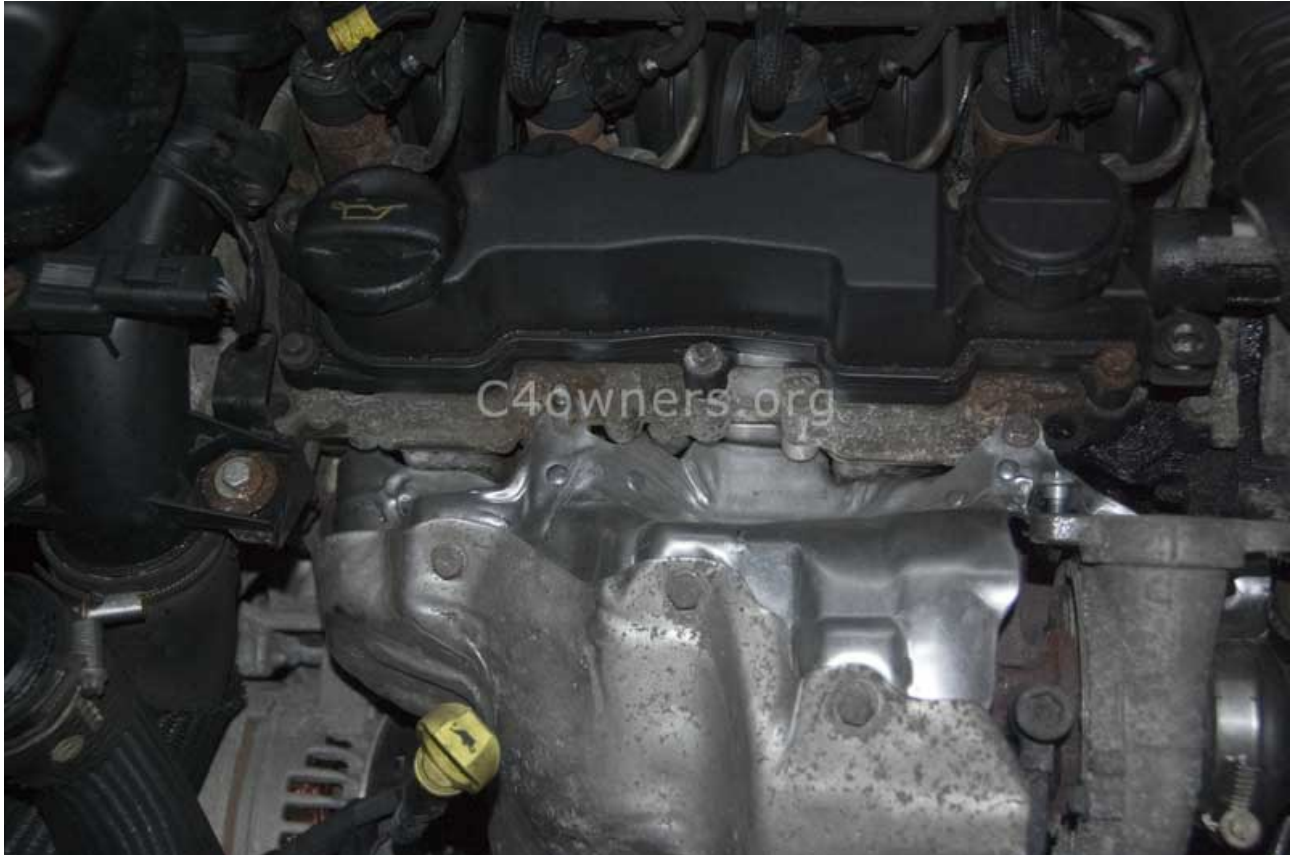
Once out you simply re-fit in the reverse order.

Fit the shield ensuring the bolts are tight starting with the 2 engine side ones, then the 3 at the joint.

Refit the Turbo Resonance Suppressor making sure it's seated correctly and the bolts are tight.
